Single Device Characterization by Nano-probing to Identify Failure Root Cause

Chao-Chi Wu, Jon C. Lee, Jung-Hsiang Chuang, Tsung-Te Li,
Taiwan Semiconductor Manufacturing Company, Ltd.
6, Creation Rd.2, Science-Based Industrial Park, Hsin-Chu, Taiwan 300, R.O.C.
Tel: 886-3-5785112ext.2175 Fax: 886-3-5787778
ccwun@tsmc.com, Clee@tsmc.com, jhchuang@tsmc.com, ttli@tsmc.com

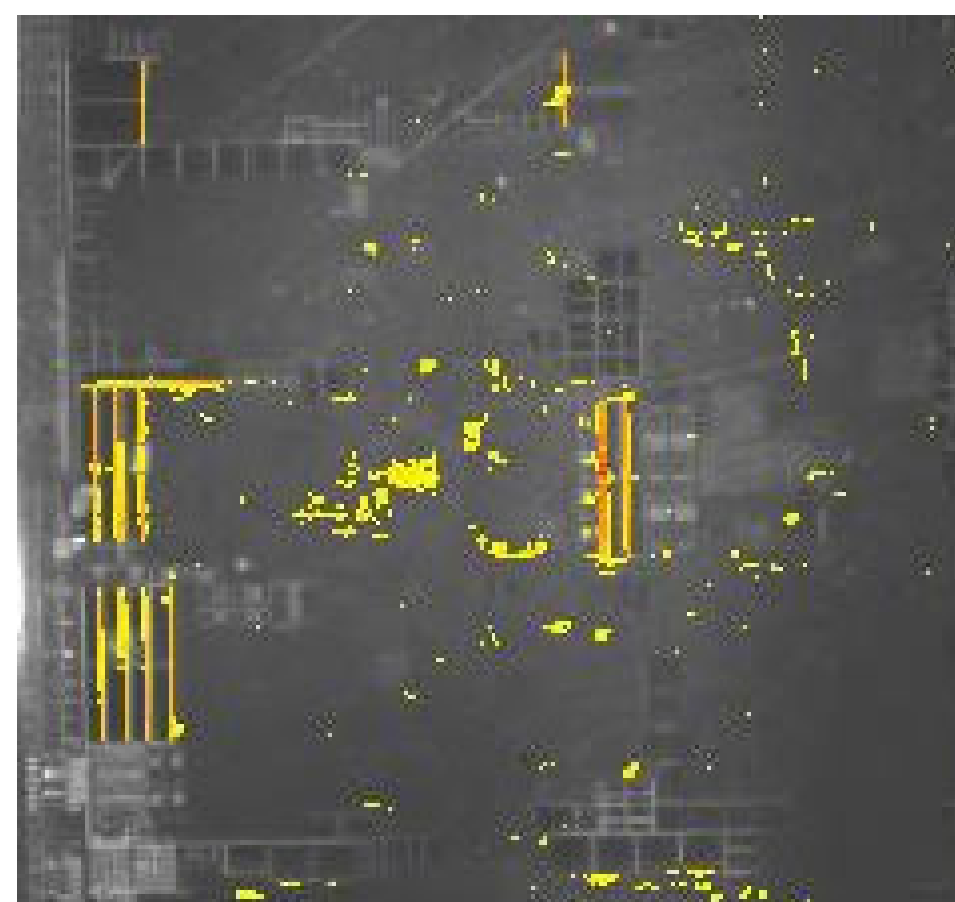
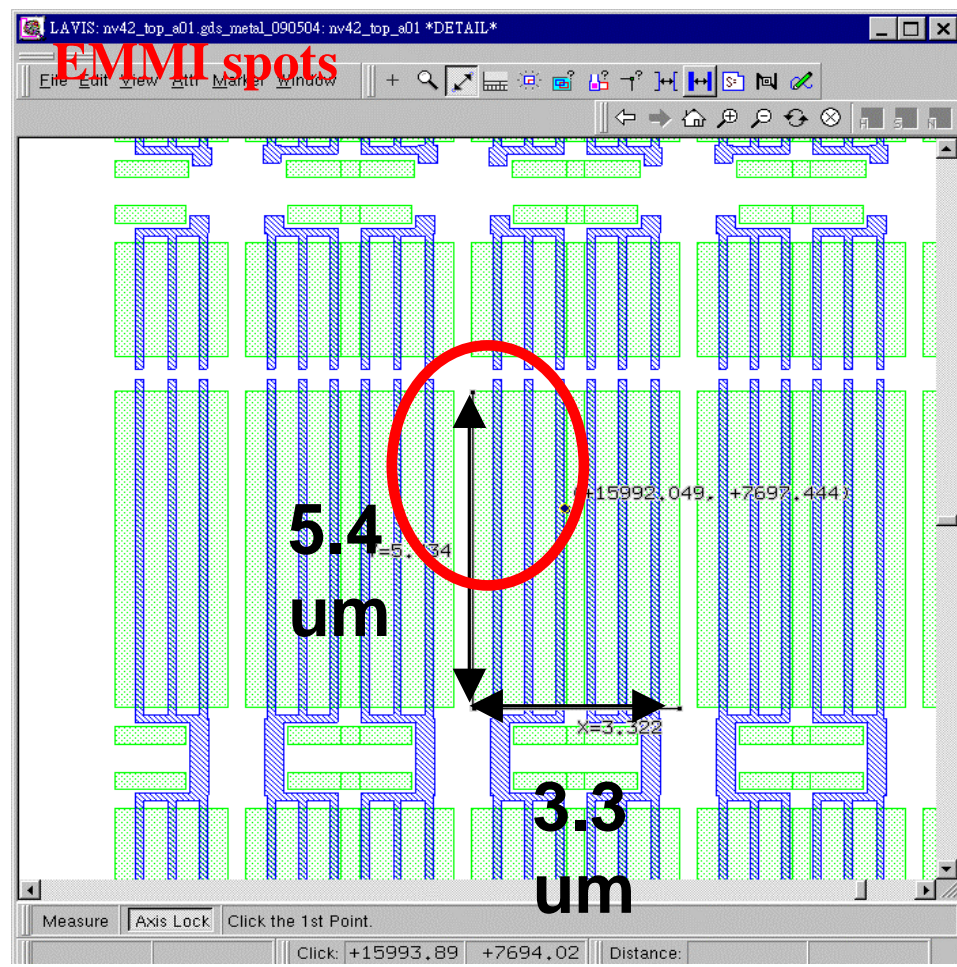
In this article, an embedded SRAM of an 110nm product was malfunctioning. Our first approach was to perform emission microscopy in an effort to isolate the potential failure area. The abnormal emission spots that are different with reference are showing in Figure 1. After mapping the emission spots to the layout, a PMOS transistor was identified as an area to focus the PFA techniques. A top down analysis utilizing parallel lapping and PVC techniques down to the contact level failed to reveal any obvious abnormalities. Since no visible defects were observed, additional characterization is needed to better understand the cause of the emitting PMOS transistor.

Figure 1. Using EMMI to isolate abnormal positions. Layout shows the EMMI spots locate on PMOS area.

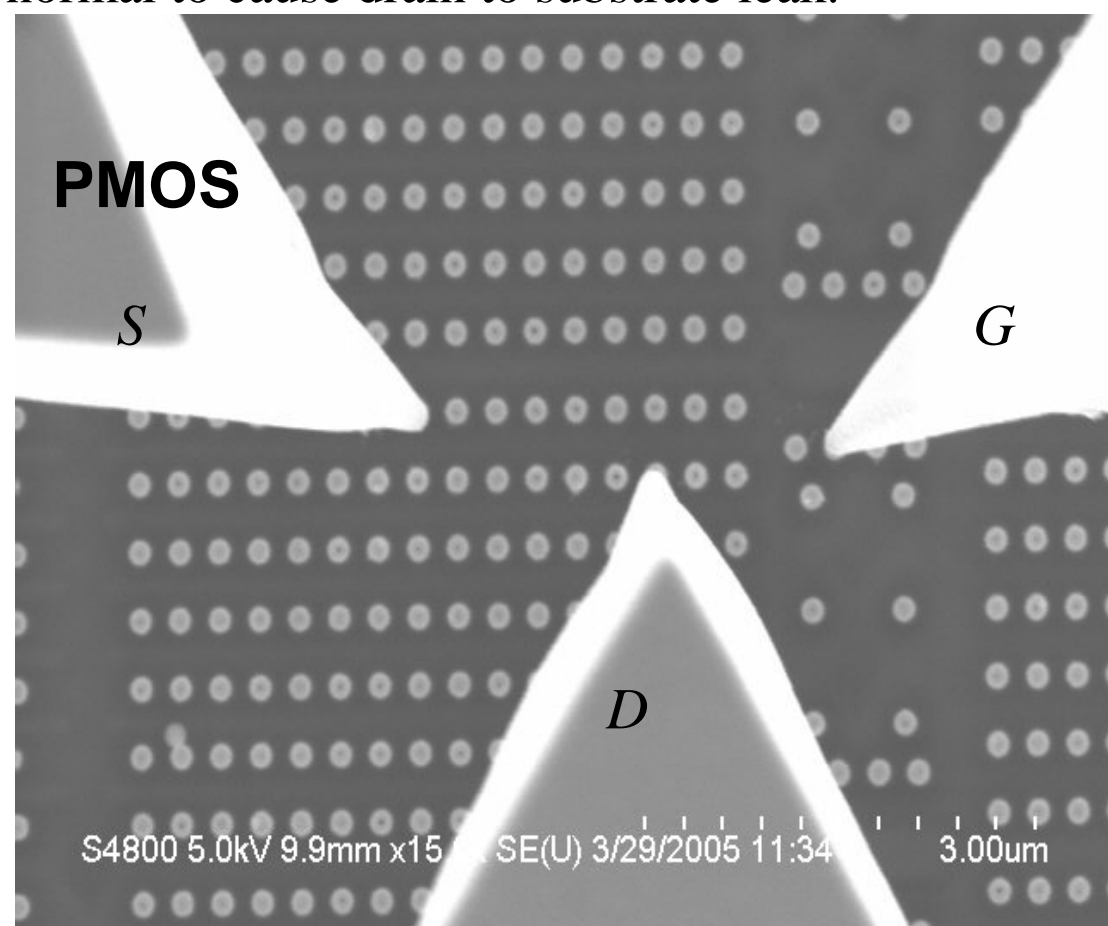
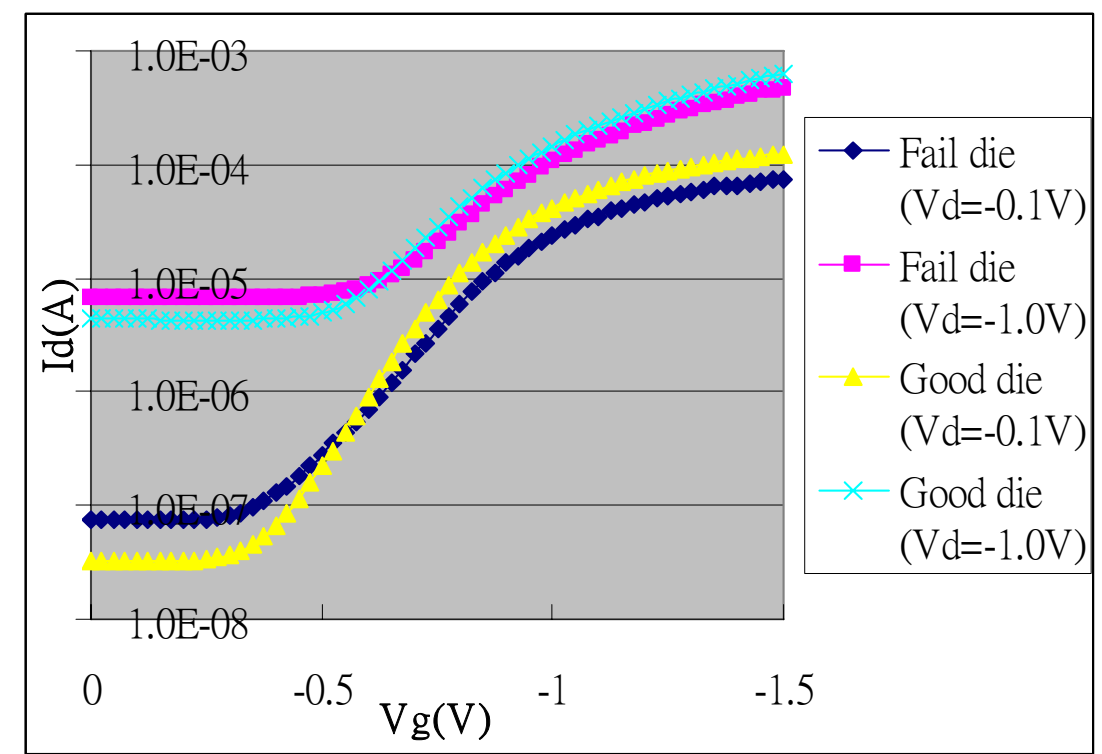
A wafer probing system with three micromanipulators (Klocke Nanotechnik) was used in the measurements, which was installed into a Hitachi FE-SEM S-4800. Utilizing this nano-probing technique, we can measure the device characteristics at the contact level (Figure 2). After comparing the I/V curves of the emitting PMOS transistor with a reference PMOS transistor, an abnormal electrical characteristic can be observed on the emitting transistor (See Figure 2). The I/V curve of bad transistor shows a lower I_{sat} and higher I_{off} current. In order to understand the leakage path, the current components of Source, Drain, Gate, and Well/substrate node shall be checked (See Table 1). Analysis of the electrical results indicates the leakage path of the emitting transistor is between drain and substrate.

In order to further validate the electrical measurements, a PMOS transistor on the periphery was also used for confirmation. After comparing its result with a reference, the behavior was the same. So the difference of PMOS found is reliable, it should be something abnormal to cause drain to substrate leak.

Figure 2 Device behavior is different between the PMOS transistors of bad and good dice. The device of bad die has higher Ioff.

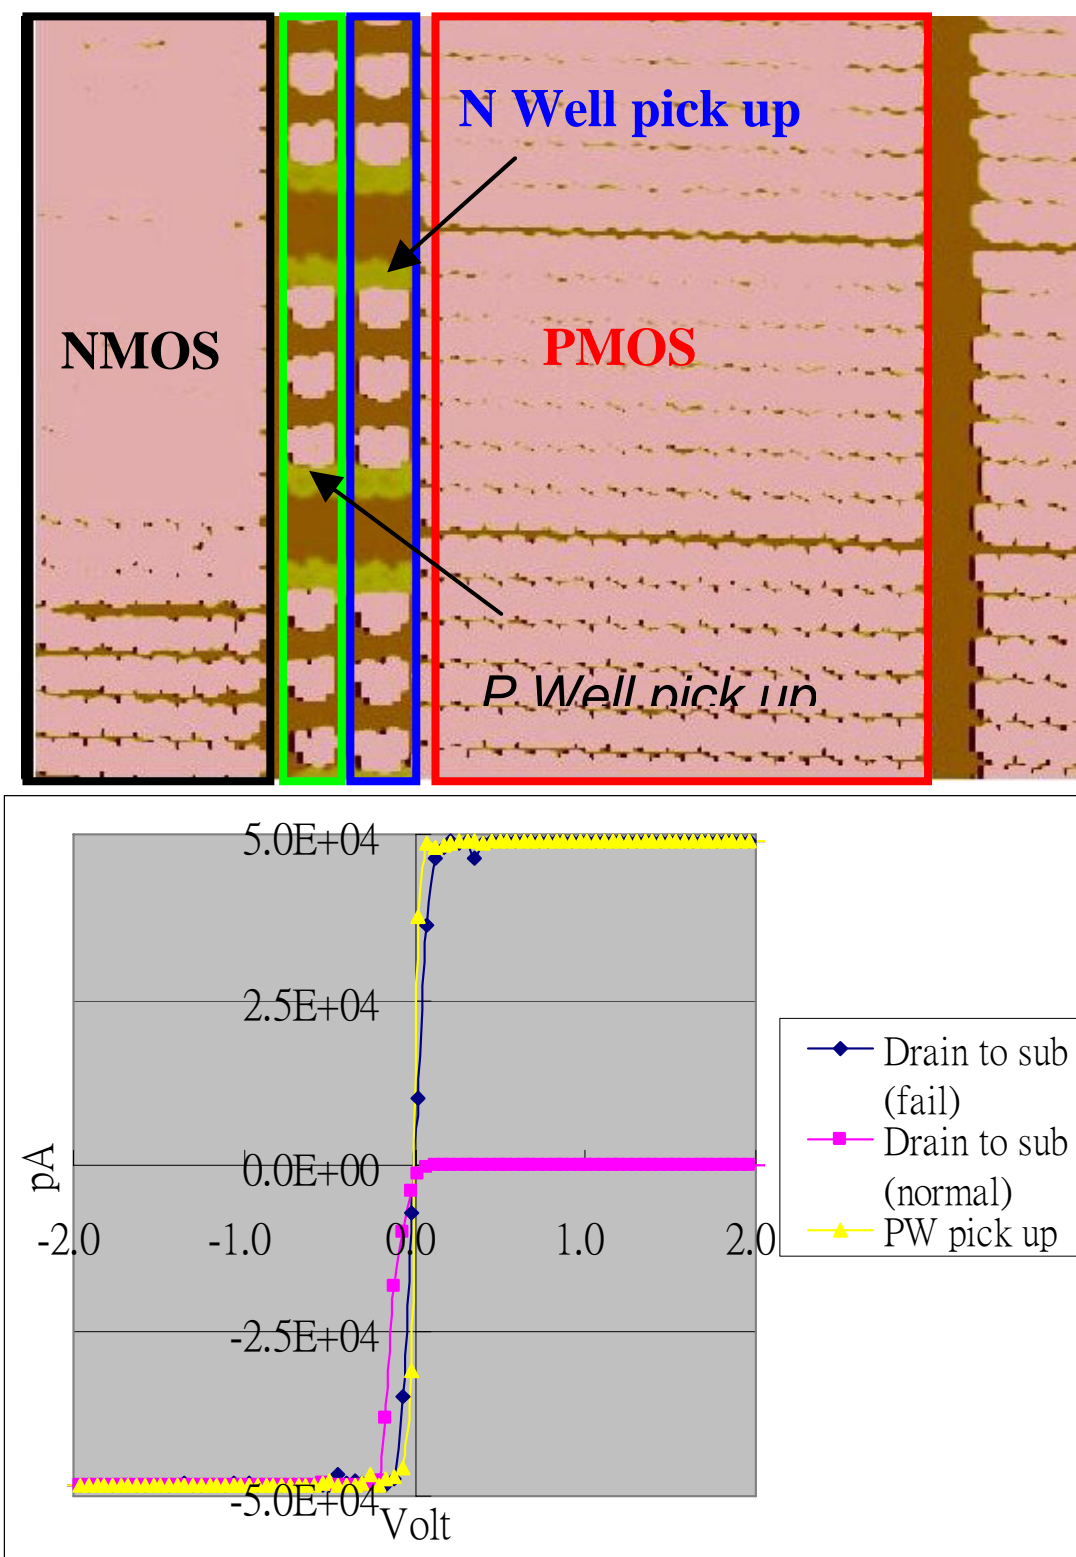
The conductive-AFM (C-AFM) has already been widely used in FA cases and has become a standard FA tool to identify failure location and help for realizing the failure mechanism by current map and I/V curve [4]. As mentioned above, the emitting PMOS transistor was caused by a junction leakage issue. To further confirm the results obtained using nano-probe technique, C-AFM technique was used. A current map of the area was obtained using a CAFM (shown in Figure 3) In the current mapping image (positive bias from substrate to tip), the N+ contact area is chosen to display a bright color; however the P+ contact area shows the same color as the N+ contact. This behavior indicated there was a leakage path between P+ contact and substrate. Checking the I/V curves of the different contacts to substrate (Figure 3), the behavior of P+/N-well (blue curve) seems like that of P-well pick up (yellow curve), not a normal P+/N-well (pink curve). This phenomenon is meaningful, and it indicates the leakage is most likely caused by a well issue.

Figure 3 The P-well of current mapping image should be dark. The I/V of abnormal drain to substrate seems like P-well pick up behavior.

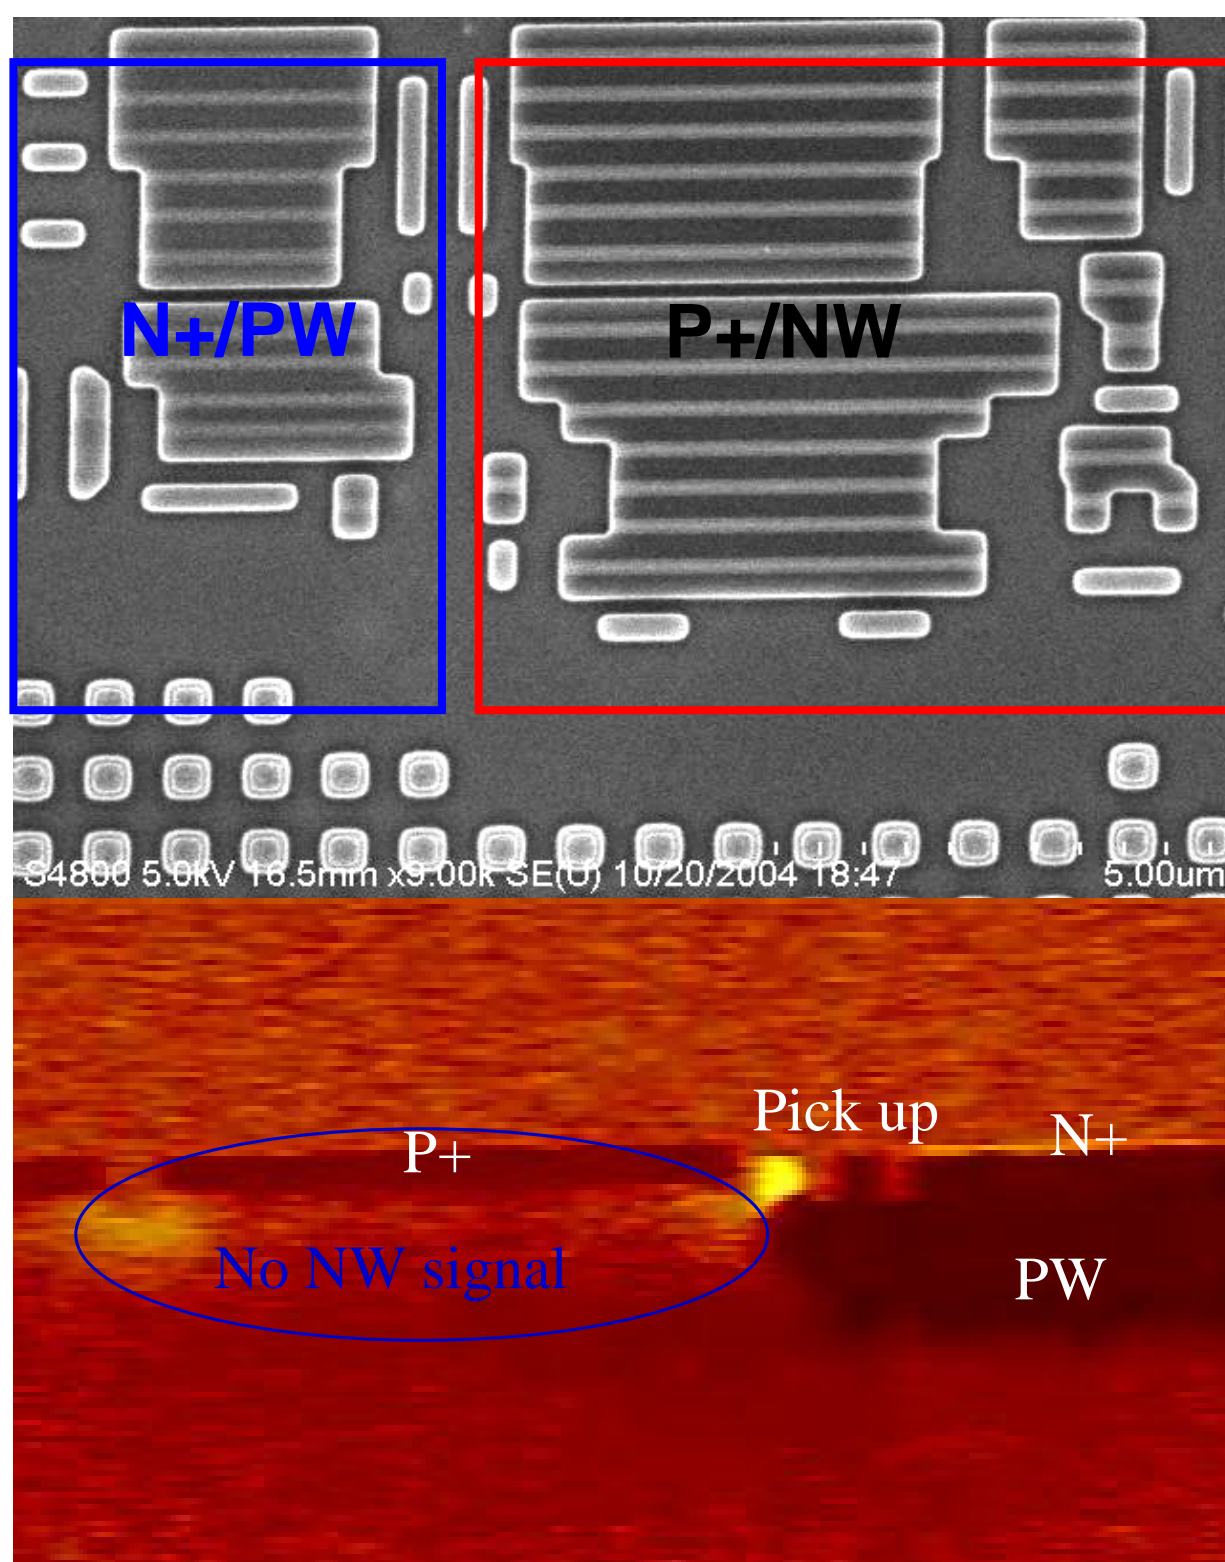
To prove this theory, PFA evidence for N-well implant was needed. Figure.4 shows the plane view junction stain and x-section SCM (Scanning Capacitance Microscope) images. In plane view junction stain image, there is no difference of contrast between N-well and P-well, so the theory of a missed N-well implant issue seems more probable. In the SCM x-section image, the N type implant signals will be set on bright colors. However, in the N-well implant area, the signals are not clear. This result indicates no N-well implant is indeed

the root cause. After verifying all of the N-well implants steps, the mask issue of N-well implant is identified.

Figure 4. Junction stain shows there is no difference of contrast between N-well and P-well, which should be due to the problem of N-well miss implant. A SCM x-section image indicates no N-well implant indeed.
